Report No. CG-D-02-98

IMPROVED INSPECTION OF WOODEN VESSEL FASTENERS

U.S. Coast Guard
Research and Development Center
1082 Shennecossett Road
Groton, CT 06340-6096

Final Report
August 1997

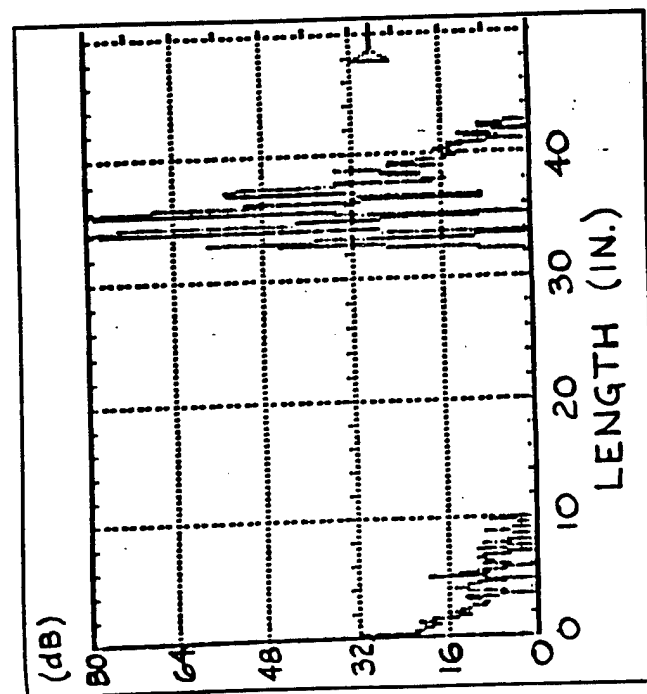
FIGURE 4. Ultrasonic Output Showing a Good Fastener

A-scan of 32-inch long copper alloy drift pin in the starboard sister keelson (sail locker area). The pin is in good condition with light wastage on the inboard 8-10 inches.

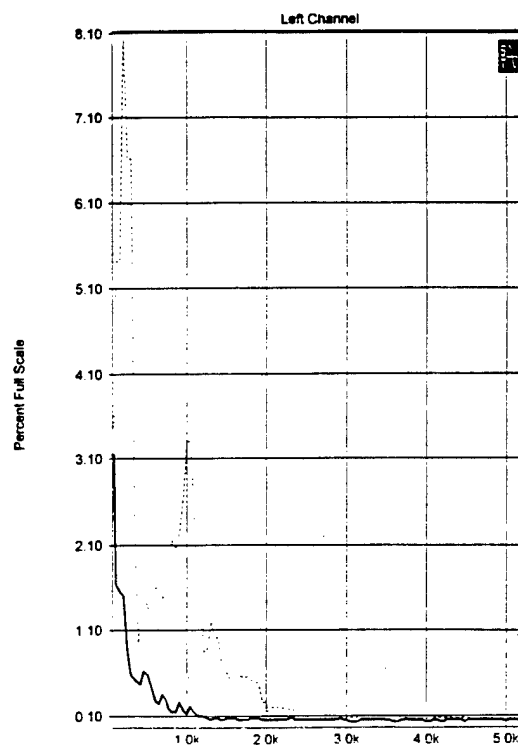
FIGURE 23. SMART HAMMER Results of good vs rotten areas
(dotted line = good plank, solid line = rotten area)

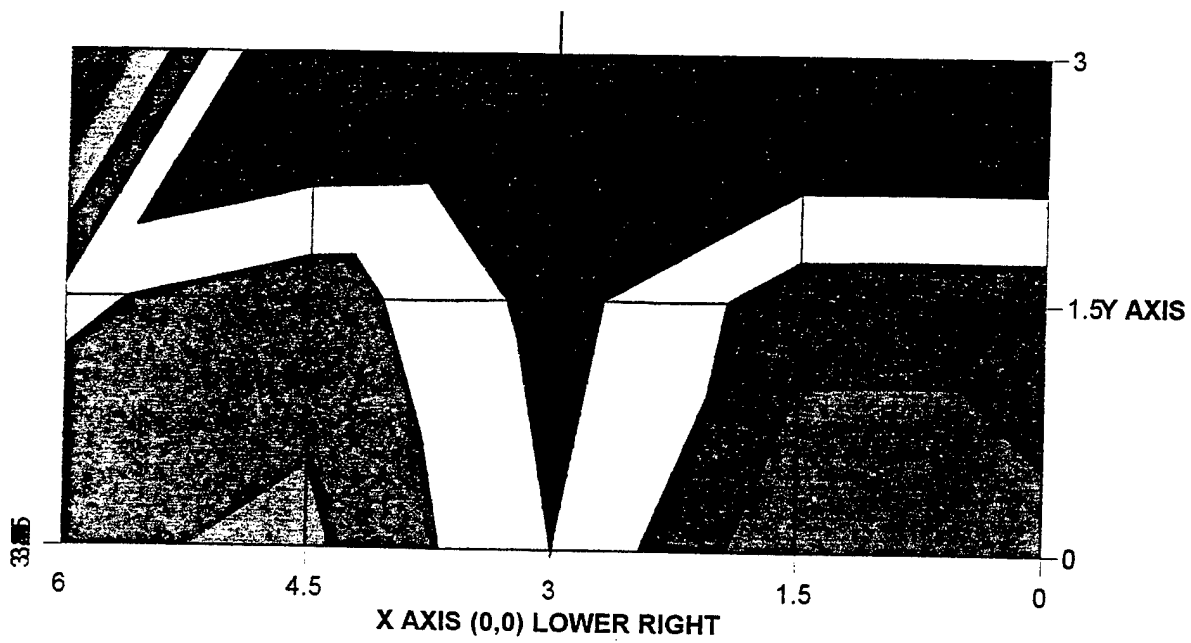
FIGURE 30. Capaciflector Results Questionable Joint

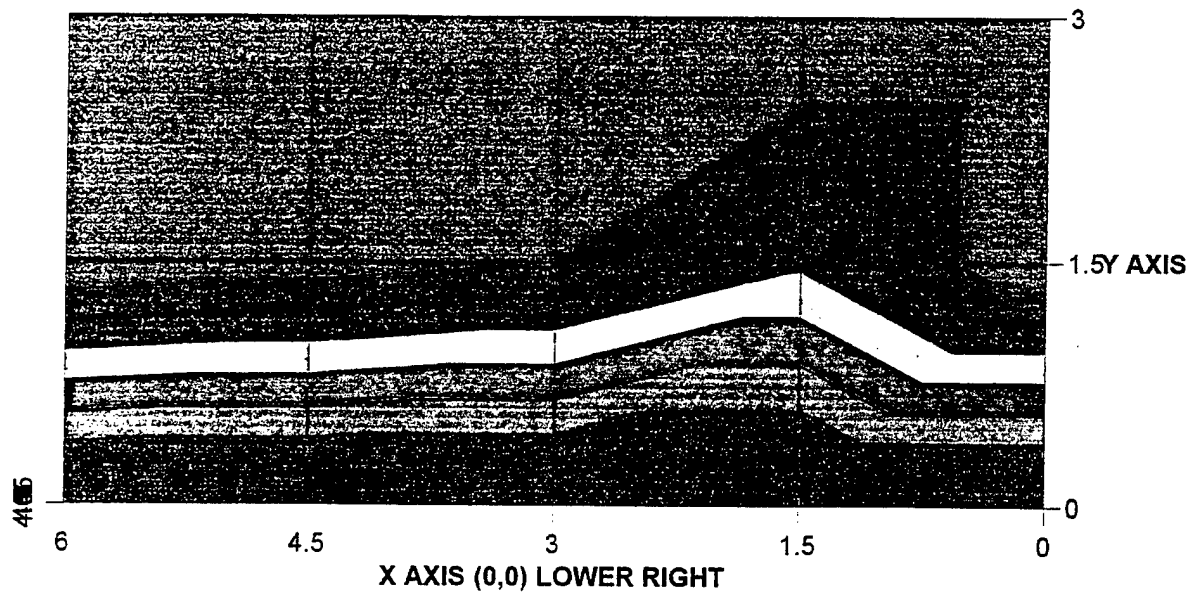
FIGURE 31. Capaciflector Results Good Joint

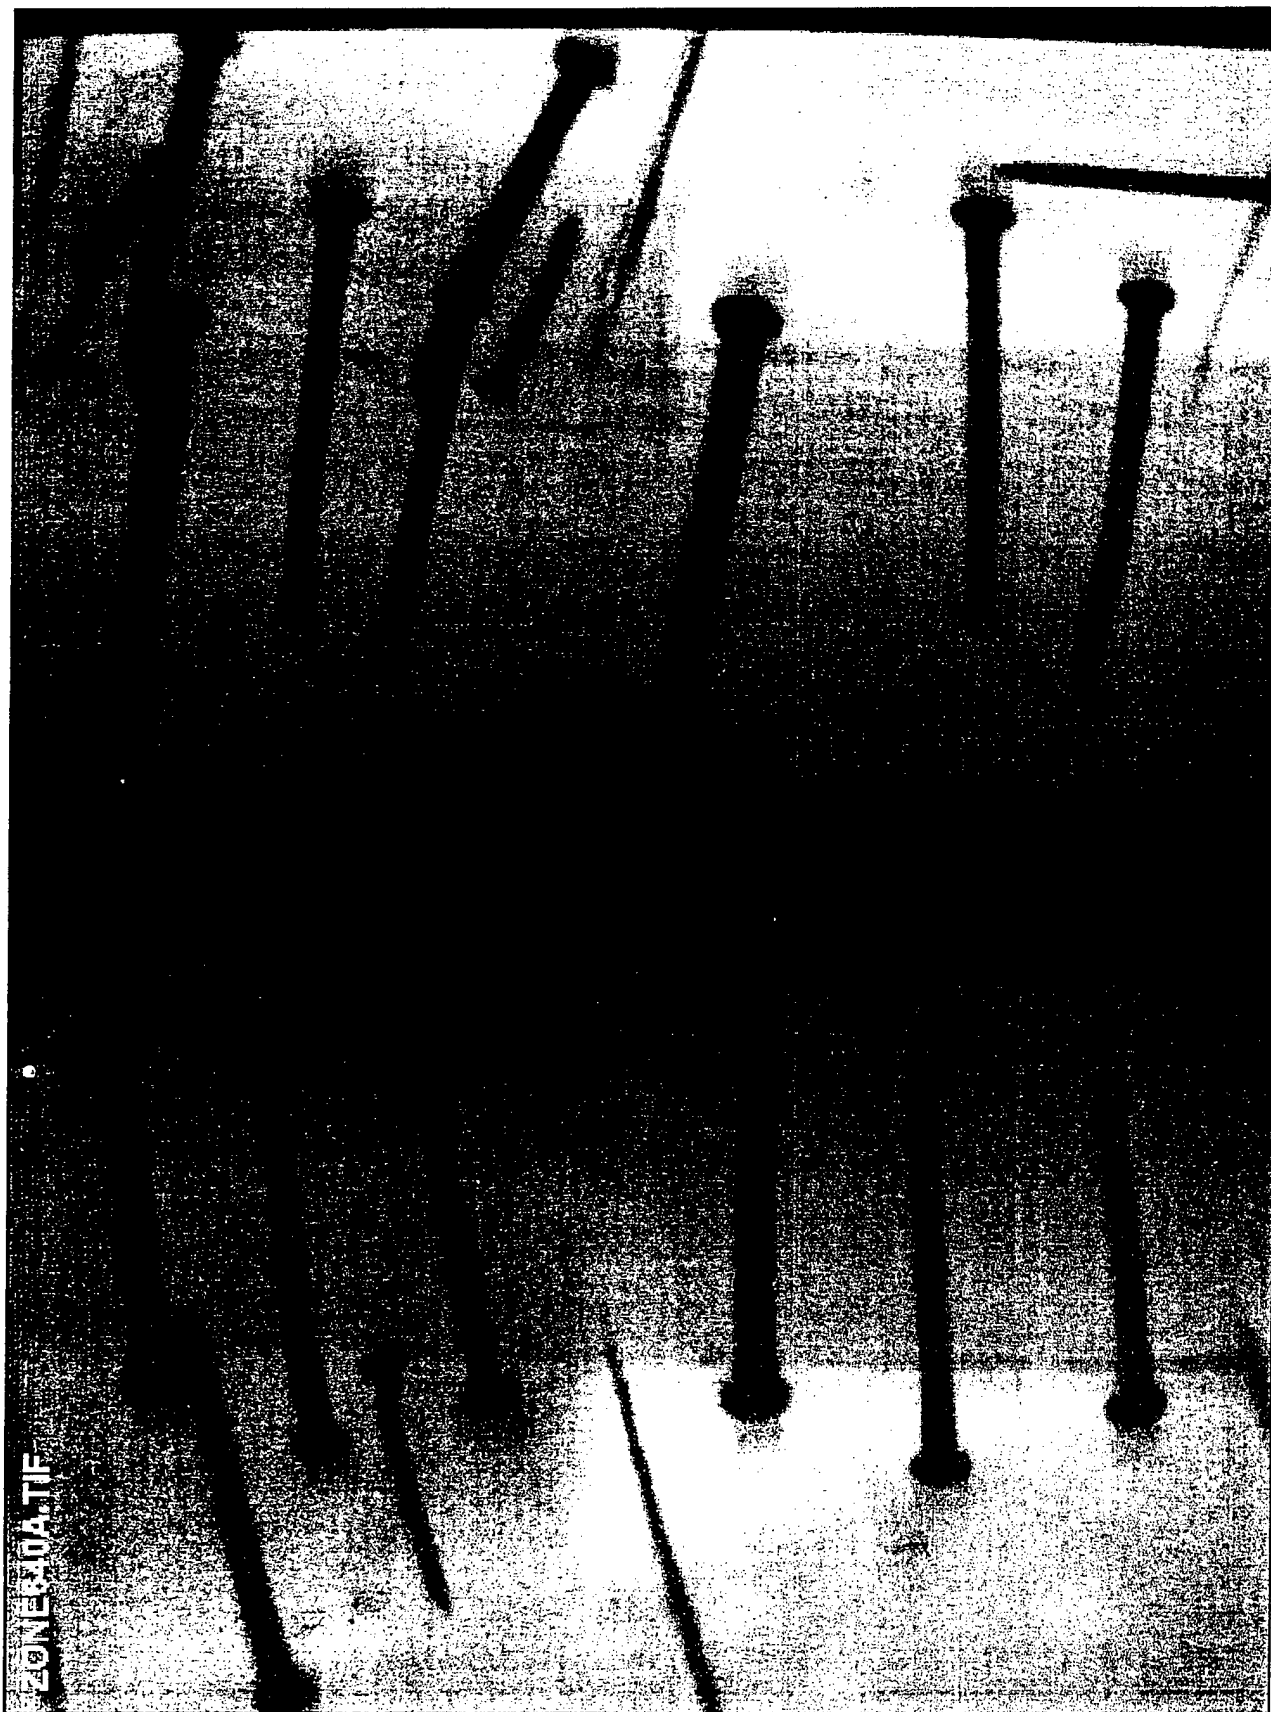
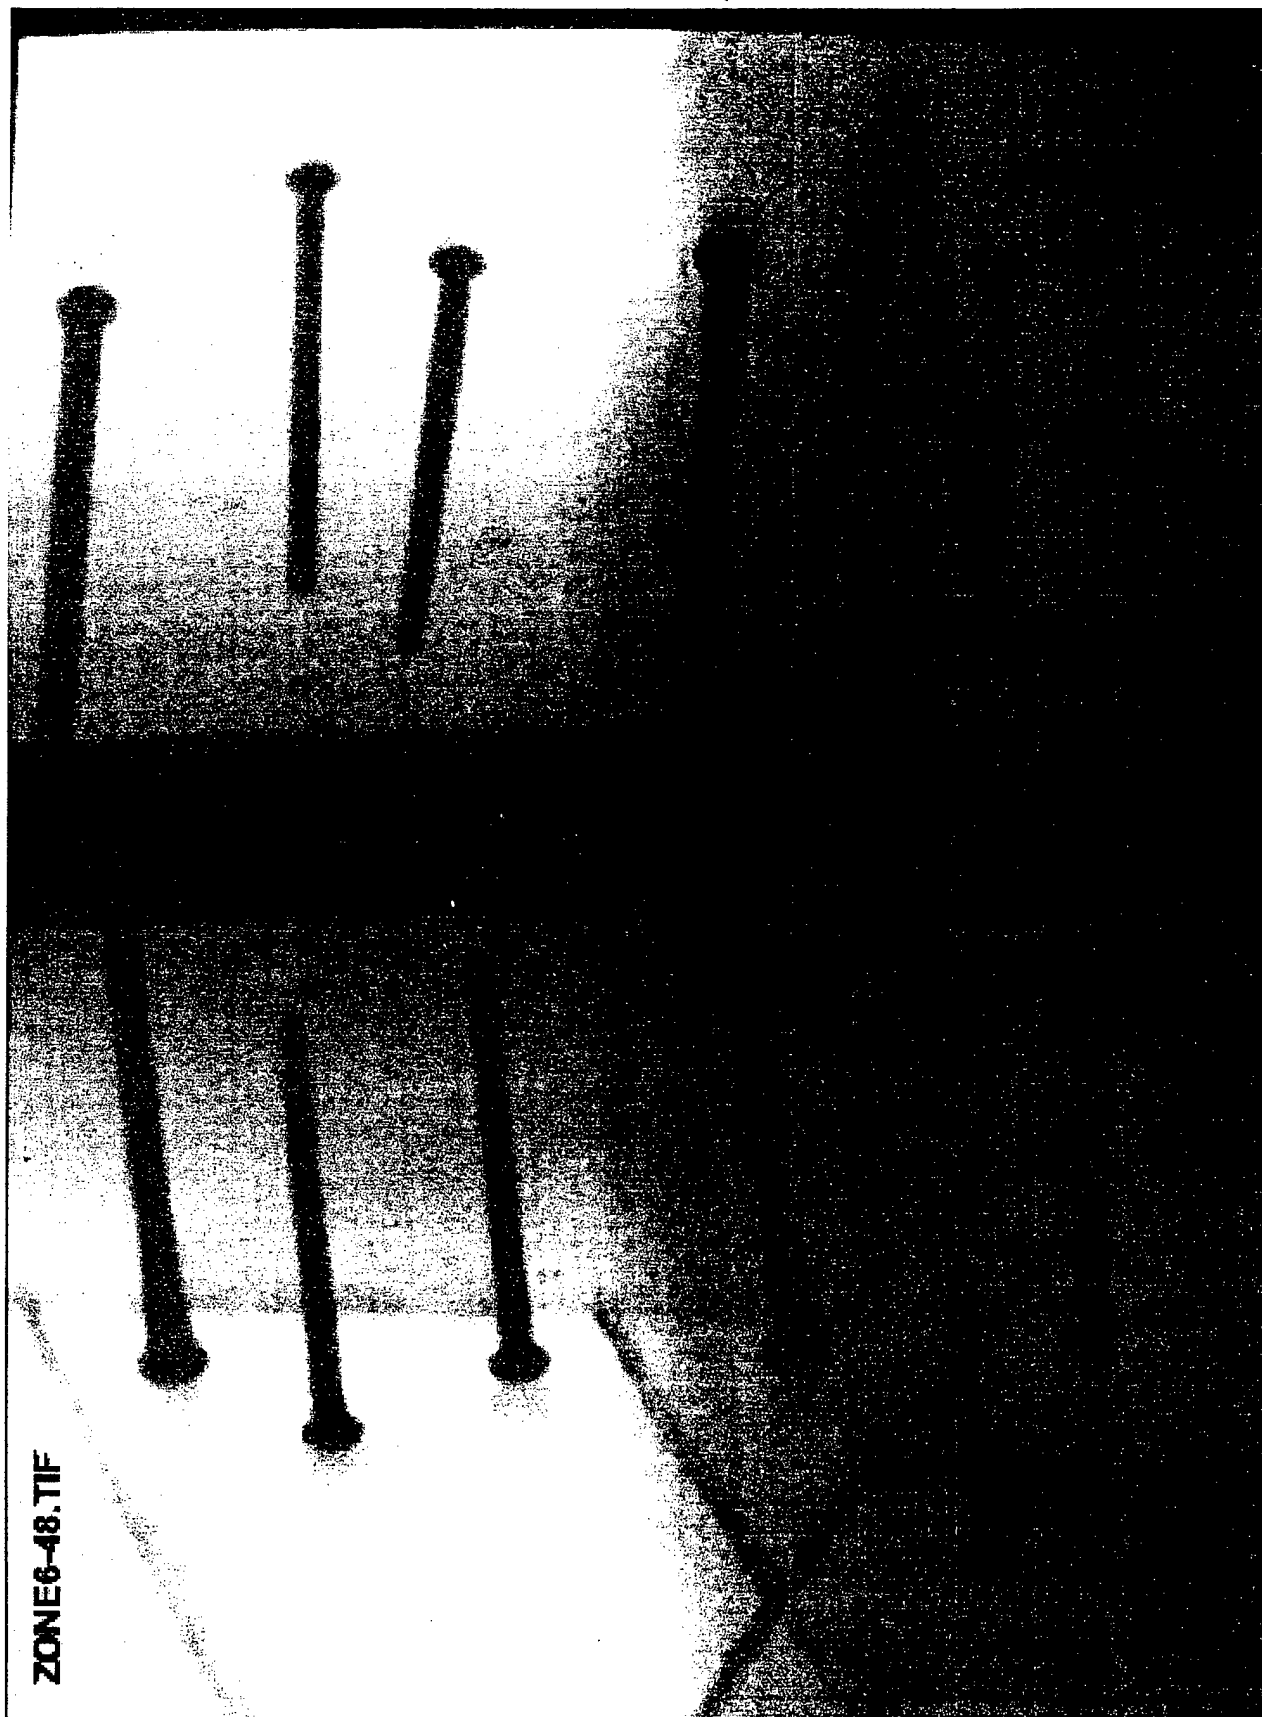
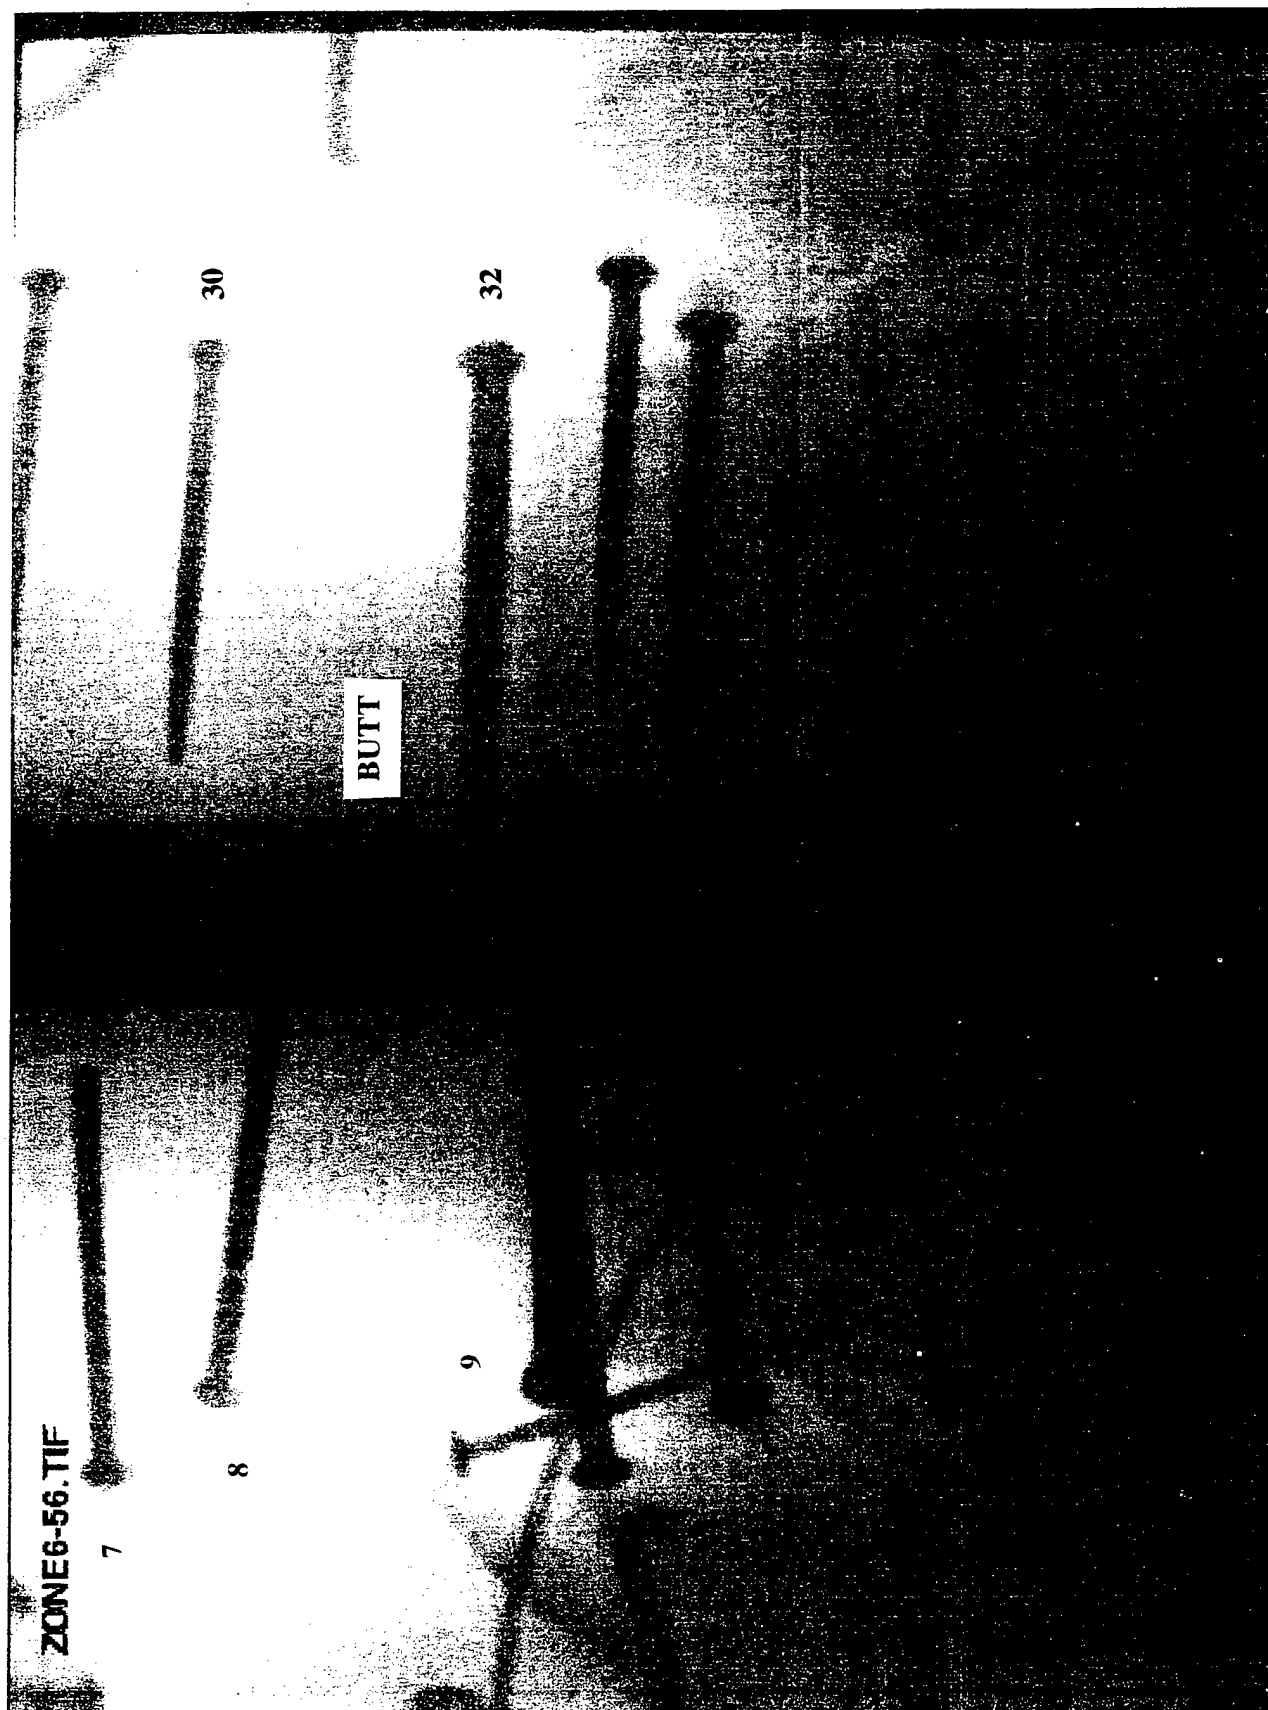
The real time x-rays were also taken with the source inside of the vessel. The three shots shown in Figures 52-54 start about 40 inches down from the deck level and step down about 8 inches each time. The butt joint in the stem band can be seen just above the center in Figure 54. There are two issues involved in viewing the figures here. First, the source was moved to different locations between some of the shots so that the relative position of the fasteners changes. Second, the lower energy real time system had some difficulty penetrating the large amount of structure as can be seen in Figure 54. These two issues, plus the lack of reference points, such as the bronze bolt, make it difficult to interpret the results.

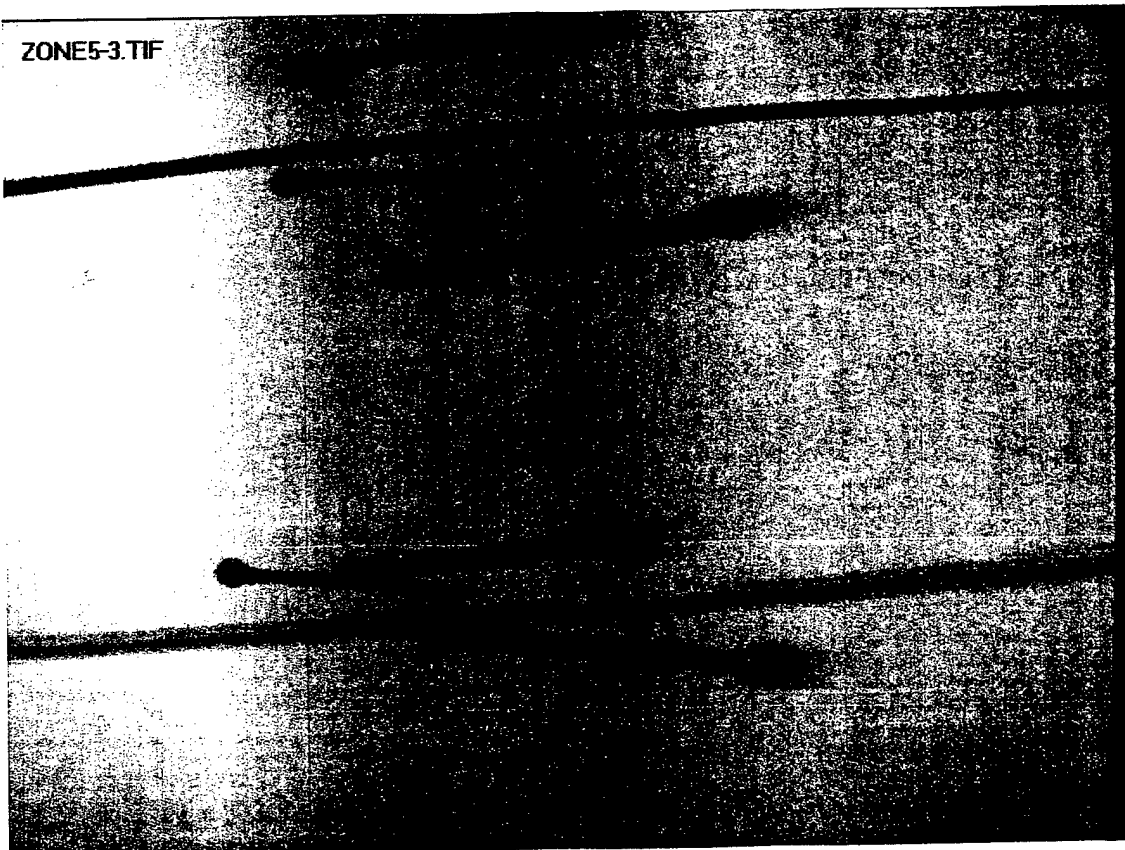
FIGURE 55. Real Time shot of Area 5

There were x-rays taken of other parts of the vessel, but conventional and real time shots were not taken in the same place. Real time shots were taken of Area 5 because the equipment was portable enough to be moved to that area. (Figure 55) The plank and the ceiling fasteners can both be seen. As expected, the fasteners in this area are in good shape and this was confirmed when taken apart (See Figure 56) Holes can be seen where the fasteners were removed.

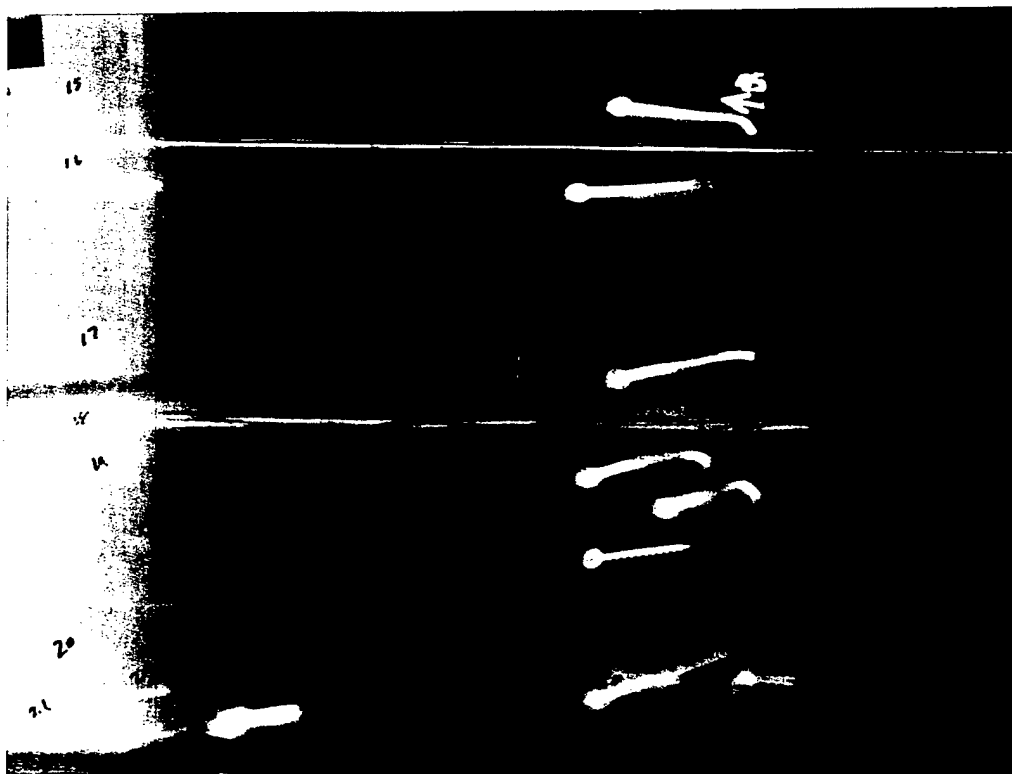
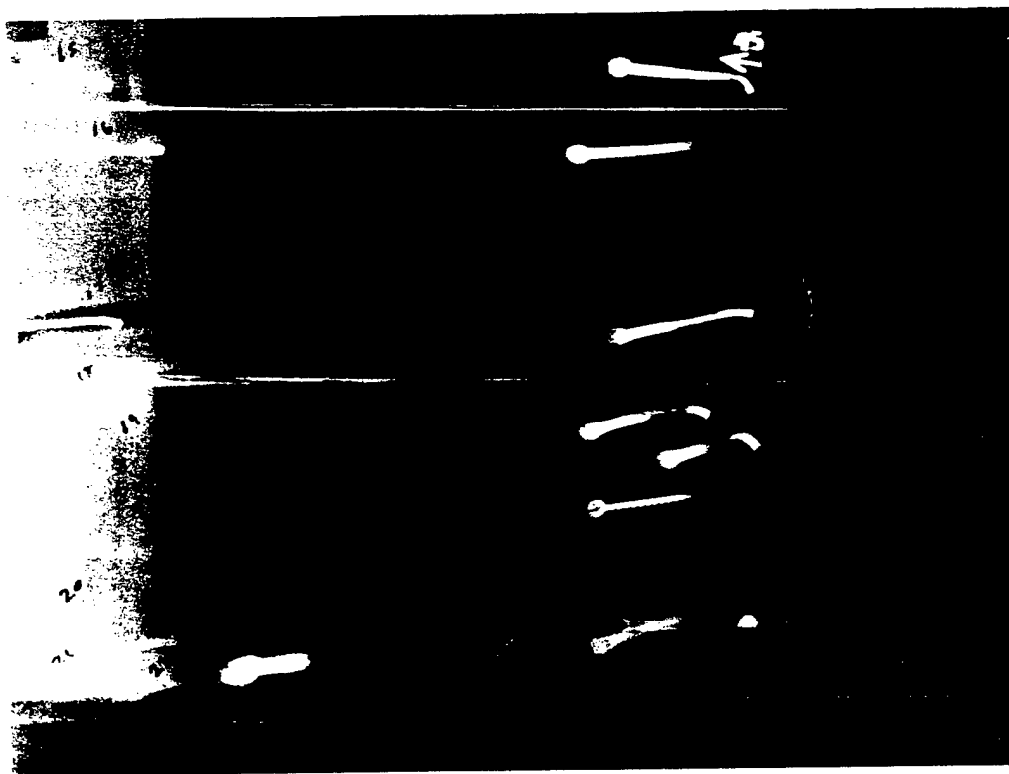
For the shots taken at a 45 degree angle, two different films with different speeds were used. The normal medium speed (ASA 80) is used in Figure 73. For these shots, the film was placed back to back and only one exposure time was necessary. As a result, the faster film (ASA 100) shown in Figure 74 appears darker. In actual use, the exposure time could be reduced for this faster film or a thicker piece of wood could be examined. Both show the condition of the fasteners in sufficient detail, although the light film picked up other details. The real time shot (Figure 75) also detects the fasteners. In addition, the 45 degree shots show that fasteners are in two pieces which is not as obvious in the real time 30 degree shots, especially for the fastener just above and to the right of the sheetrock screw. Also note that the fasteners near the bottom of all of the figures have lost the clinched ends. These detached when the hull was disassembled and they contained insufficient strength. A real time shot was taken at a 60-degree angle (see Figure 76). Although the condition of the fasteners can be determined, the distortion is very severe and this amount of angle should only be used for special cases.

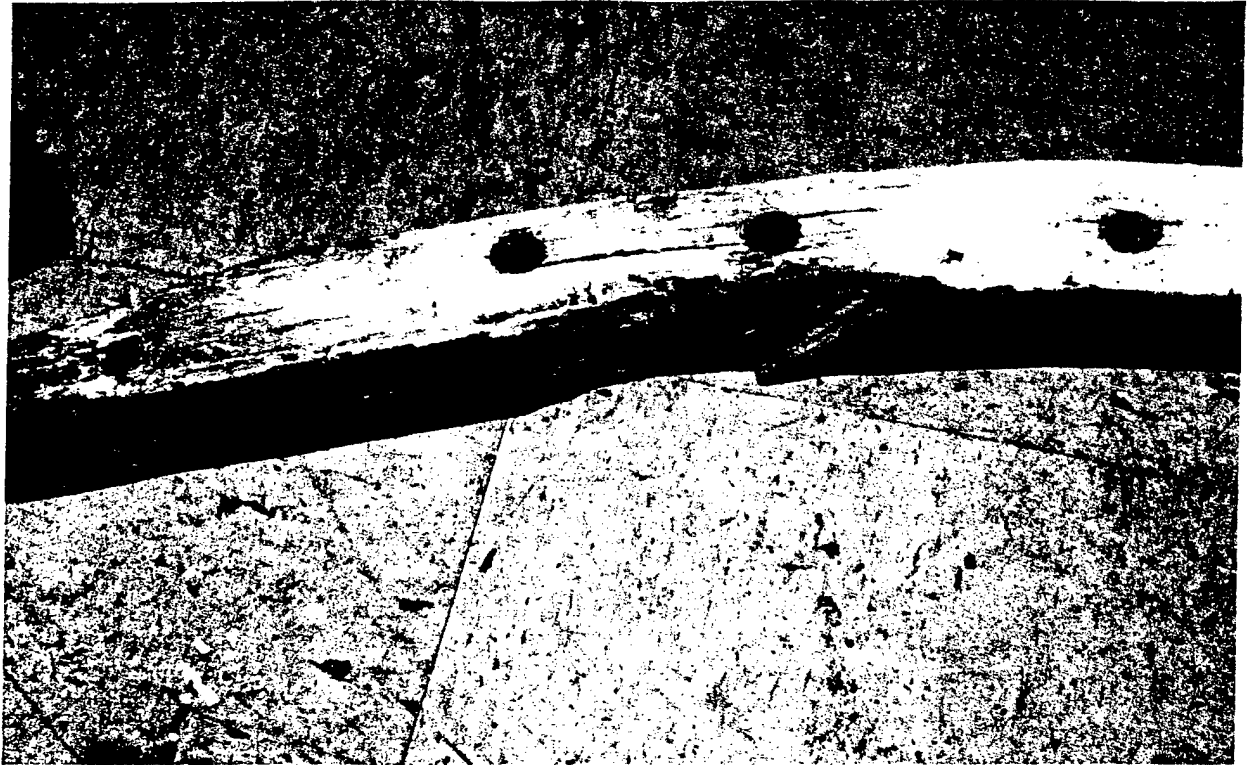
Finally, two shots were taken of a bent frame from another vessel to show the difficulty in interpreting results due to coatings. Figure 77 shows a view of the frame and a corresponding x-ray in Figure 78 (shown on top of a 2x4). Even more dramatic are the coatings shown in Figure 79 which result in an x-ray with varying density (see Figure 80). The changes in the darkness of

79 which result in an x-ray with varying density (see Figure 80). The changes in the darkness of the x-ray are due to wood density, coatings and thickness of the piece, so all these variables have to be considered when using x-rays.

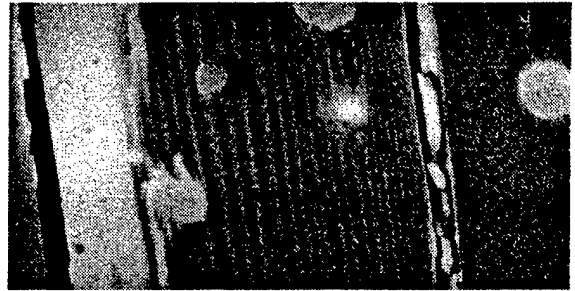
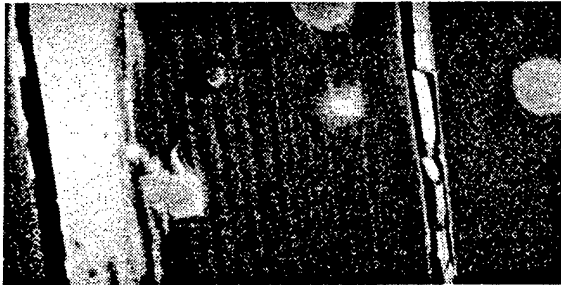
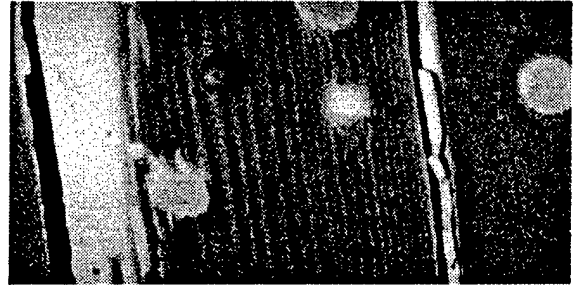
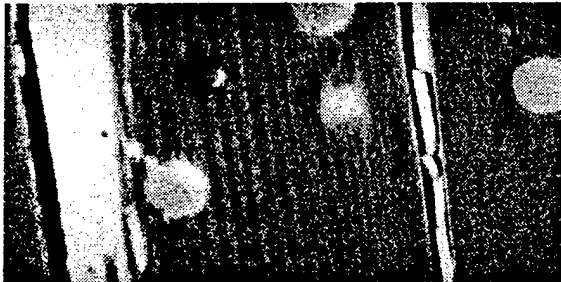
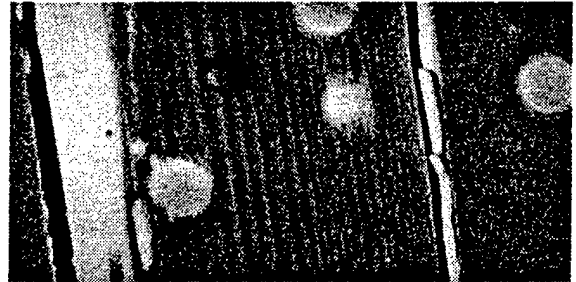
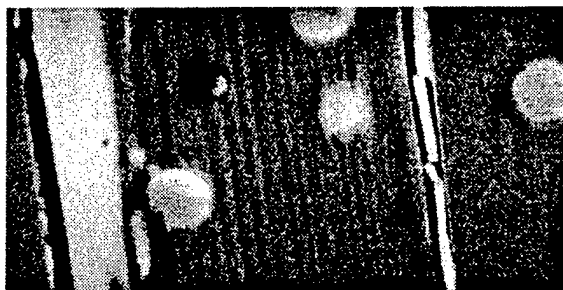
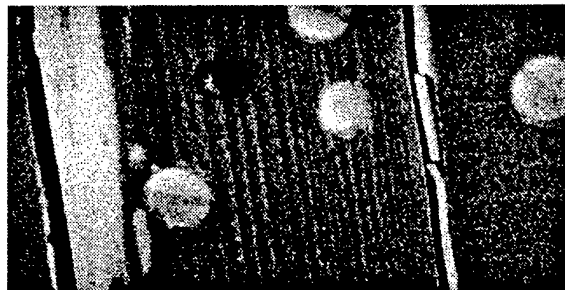
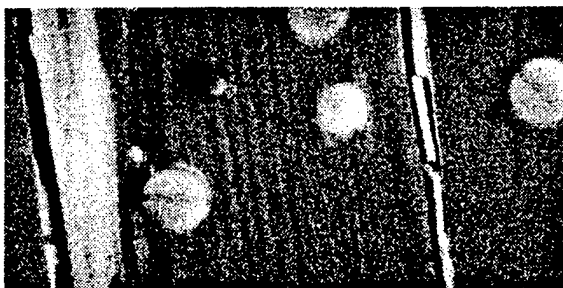
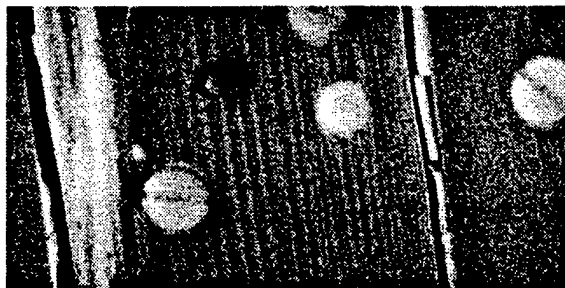
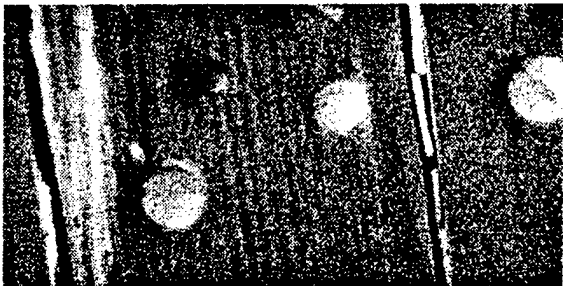
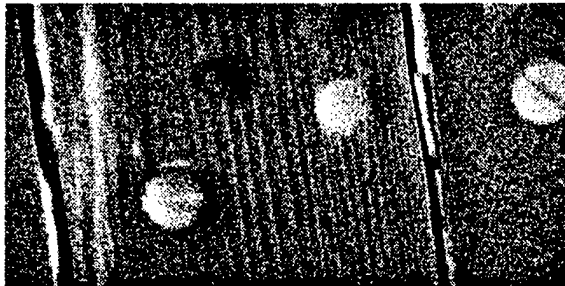
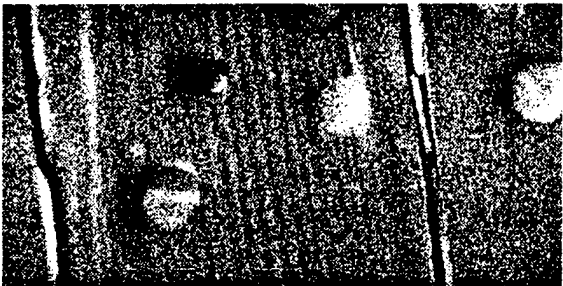
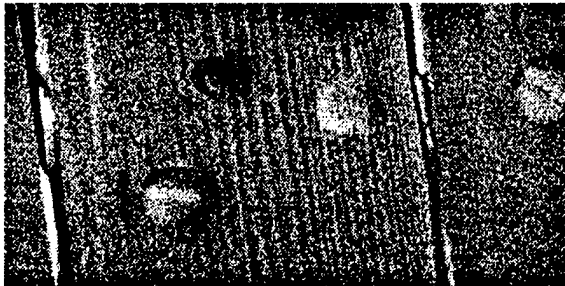
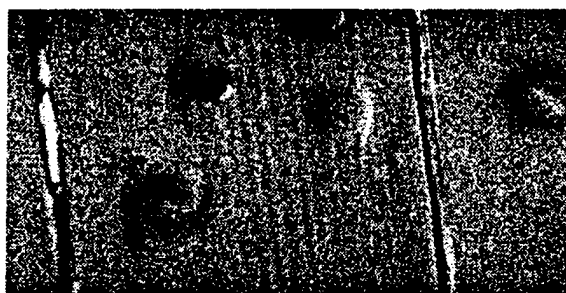
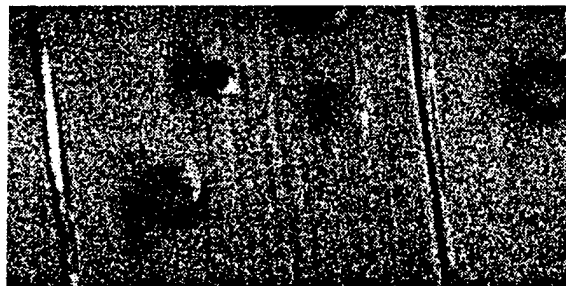
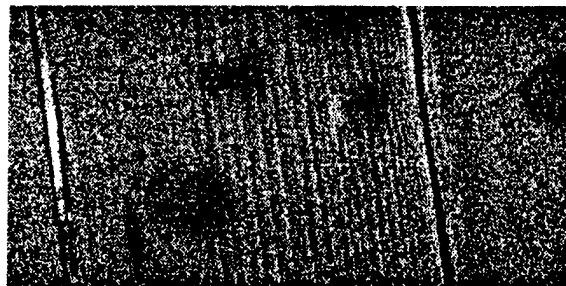
FIGURE 81. Backscatter X-ray Results

An x-ray backscatter method was attempted using a system developed by the Naval Research Laboratory. A set of images is seen in Figure 81. Each image represents a 50 mm by 100 mm (about 2 inches by 5 inches) slice about 0.5 mm thick. It is easy to identify caulk, screw hole filler, fasteners and changes in wood density. The hole filler material is seen up to about level 11 or 12 where the heads of the screws appear. The shadow of the heads continues on the images as deeper shots are taken.

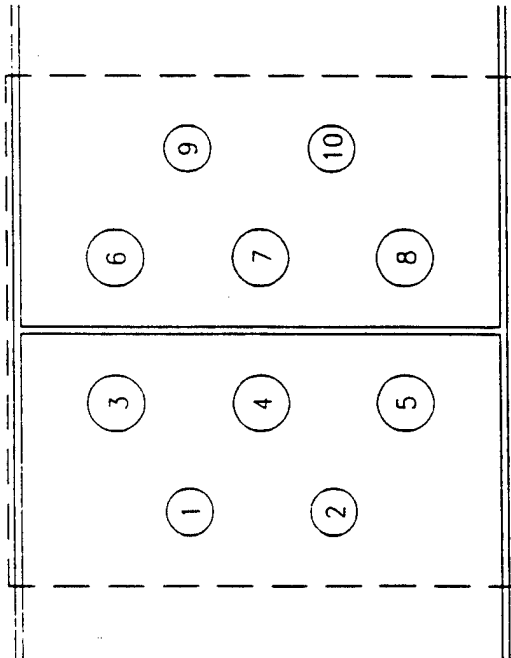
BUTT 1 (TOP)

FASTENING POSITION	FASTENING TYPE	DEFECT TYPE
T1	SCREW	S2
T2	SCREW	-
T3	BOLT	-
T4	BOLT	B1
T5	BOLT	B2
T6	BOLT	B2
T7	BOLT	-
T8	BOLT	B1
T9	SCREW	S1
T10	SCREW	-

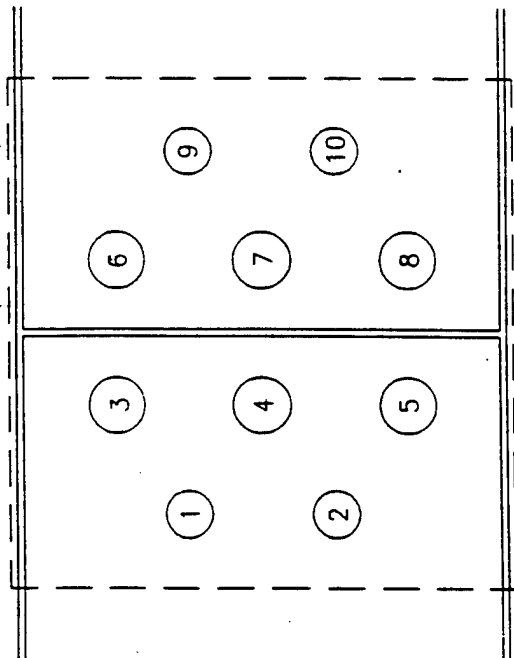
BUTT 2 (BOTTOM)

FASTENING POSITION	FASTENING TYPE	DEFECT TYPE
B1	SCREW	-
B2	SCREW	S1
B3	BOLT	-
B4	BOLT	B2
B5	BOLT	-
B6	BOLT	B1
B7	BOLT	-
B8	BOLT	B2
B9	SCREW	S2
B10	SCREW	-
